ASOS MODIFICATION NOTE 21 (for Electronics Technicians)

SUBJECT : Firmware Upgrade for ASOS Light Emitting Diode Weather Indicator (LEDWI)

PURPOSE : Removal and replacement of U11 EPROM located on the Present Weather Sensor, Microprocessor Board S100-2MT2A1A1A3.

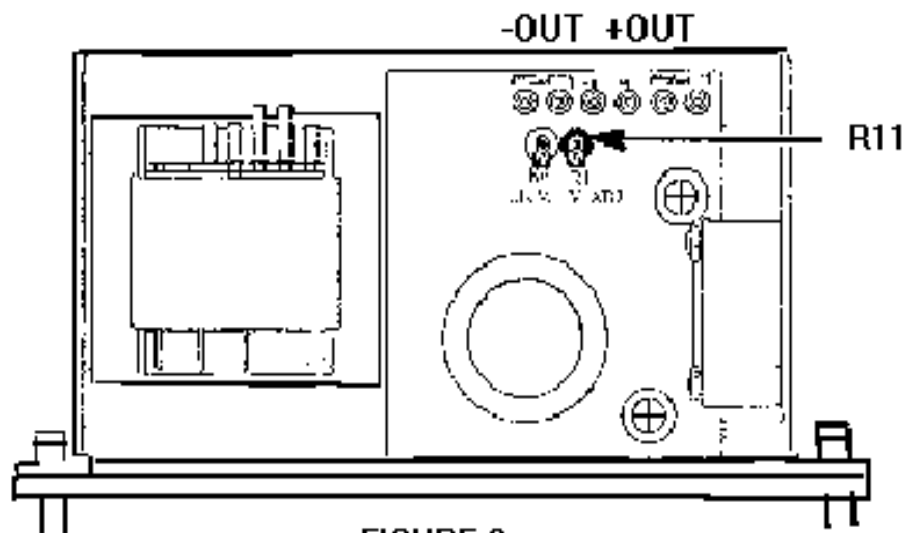
FIGURE 2

LOCATION OF ADJUSTMENT POT's ON HEATER POWER SUPPLY FRU9

1. Locate FRU9 using Figure 1.
2. Connect a DVM to FRU9 using Figure 2 as a guide. The (+) lead of the DVM connects to the (+ OUT) bifurcated terminal and the (-) lead of the DVM connects to the (-OUT) bifurcated terminal.
3. At the DCP, turn the LEDWI circuit breakers to "ON."
4. Adjust heater power supply voltage. Using Figure 2, locate R11(V. **Adj**) on FRU9. Adjust R11 clockwise until the DVM reads 28 ± 0.02 VDC. Read the DVM and record the voltage here: _____ VDC.
5. Heater power full load check and adjustment. Block the transmit beam for several minutes to turn on the hood heaters. After 2-3 minutes, determine if heaters are ON by feeling for heat.
